Technical Note N-1284

ANALYSIS OF THE CONDITION OF ECHO TOWER,  
AZORES FIXED ACOUSTIC RANGE, AFTER ONE  
YEAR AT 1500 FEET OF DEPTH

James F. Jenkins

May 1973

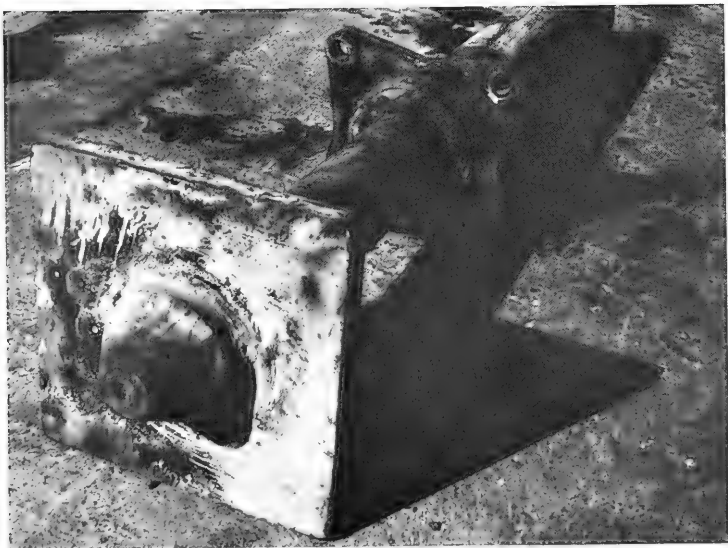
The shock absorbers, as shown in Figure 3, were covered with loose, flaky red rust and rust stains. The surfaces under the rust were etched but no pitting was noted. The area under the missing hardened tip was as corroded as the adjacent areas on the cone, which indicates that the hardened tips were lost during emplacement. Areas under the undamaged paint coating were unattacked. The paint coatings showed no undercutting adjacent to damaged areas.

Figure 3. Shock Absorber.

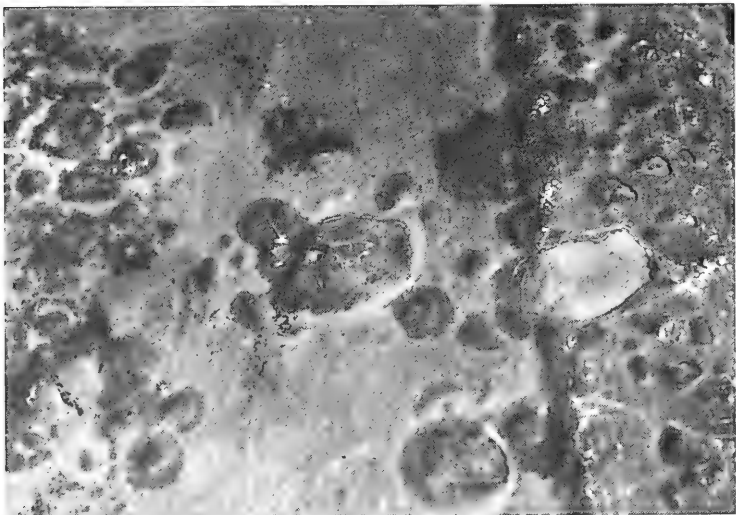
Figure 5. Blisters on steering carriage.

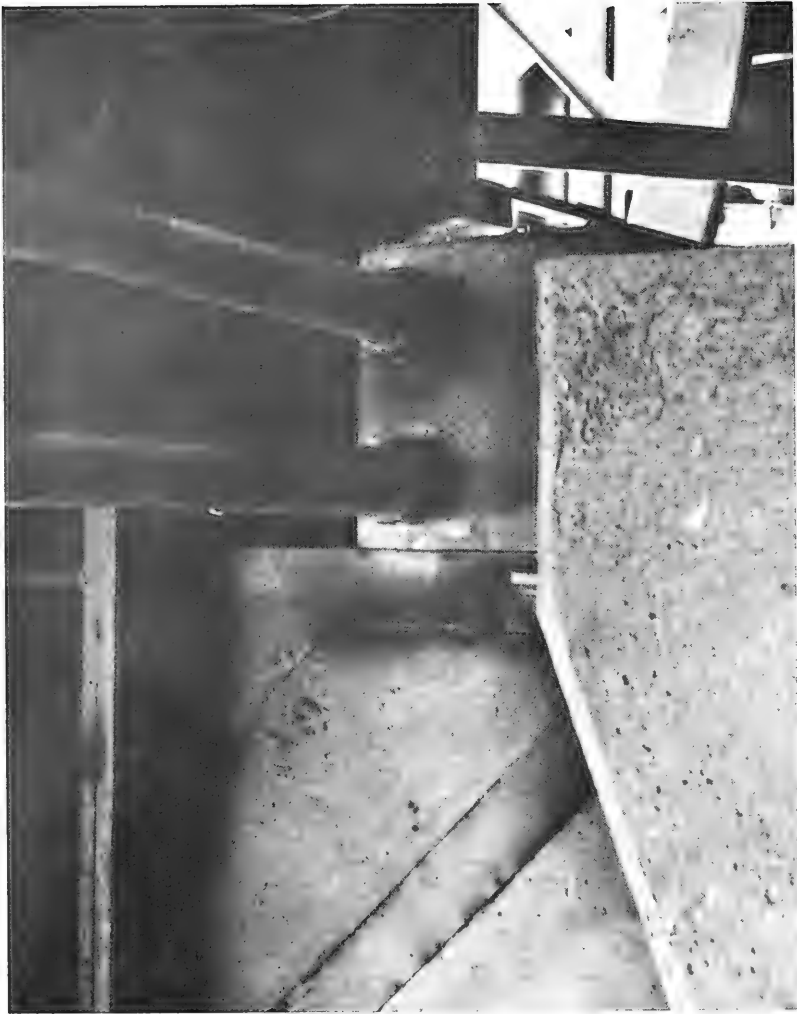
The gas generator support structure, as shown in Figure 9, had loose flaky red rust at the edges of the metal frame members. Only superficial corrosion was found associated with this rusting. The titanium cathode on the electrolytic generator, as shown in Figure 10, was unattacked. The platinum anode was also unattacked. The remaining fouling on the platinum anode was easily removed by fresh water rinsing.

Figure 9. Gas generator support structure.

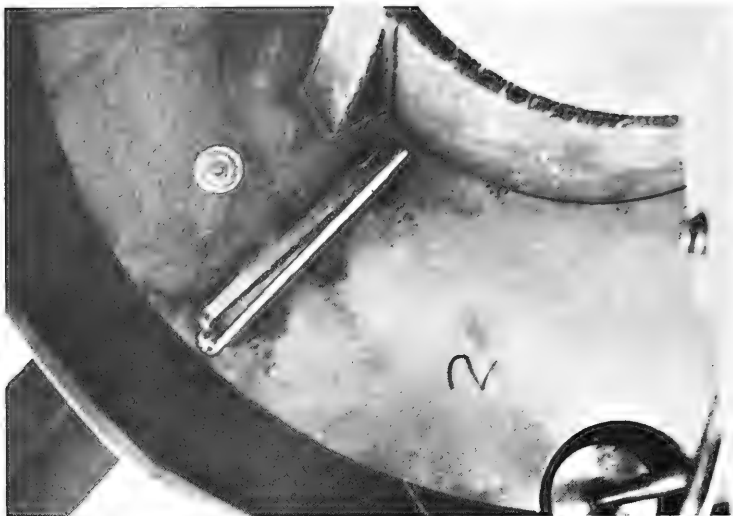
Figure 10. Electrolytic gas generator cathode.

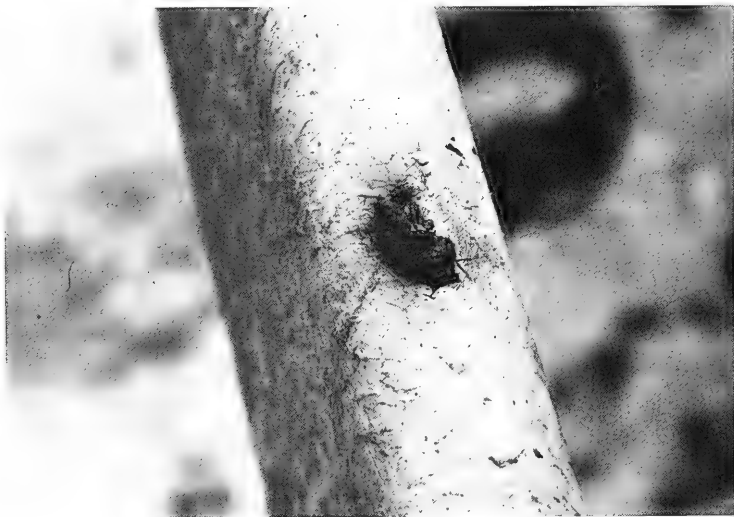
Figures 11 through 14 show the results of inspection of a typical rusted area on the middle frequency antenna. Figure 11 shows the area covered with a loose flaky red rust deposit. Figure 12 shows the area after removal of the deposit. Figure 13 shows the defects in the coating which resulted in the attack. Figure 14 shows the area after removing the coating. Note the feathered edge of the coating in Figure 14. Only three coats of paint are present. A red primer, white second coat and gray topcoat. No zinc rich primer was used on this or any other rusted areas of the compliant tubes. Brushmarks in the coatings at the rusted areas indicated that the coatings had been "touched up" at these locations without using the zinc rich primer. Removal of the upper coats of paint in an unattacked area of the low frequency antenna showed that the zinc rich primer was present.

Figure 11. Rusted area of middle frequency antenna.

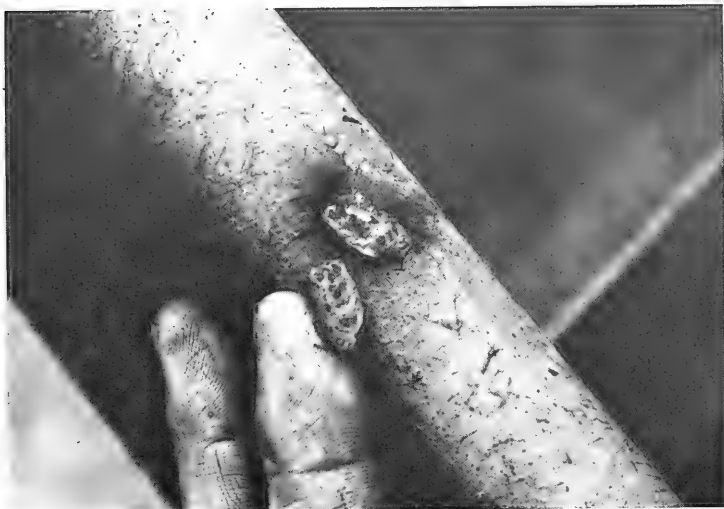
Figure 12. Area shown in Figure II with rust removed.

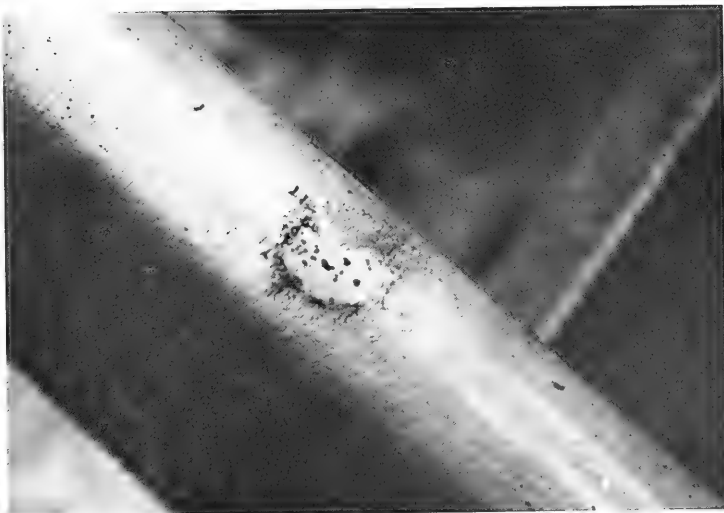
Figure 13. Same area as in Figure II with rust staining removed.

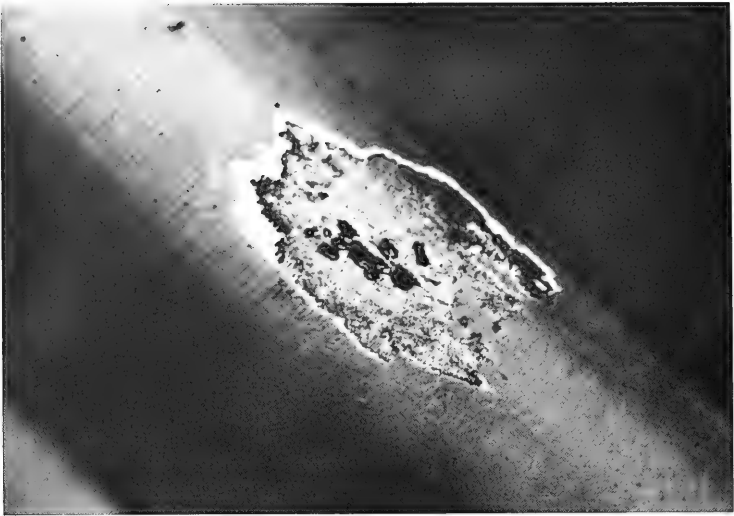
Figure 14. Same area as in Figure 11 with coating removed.

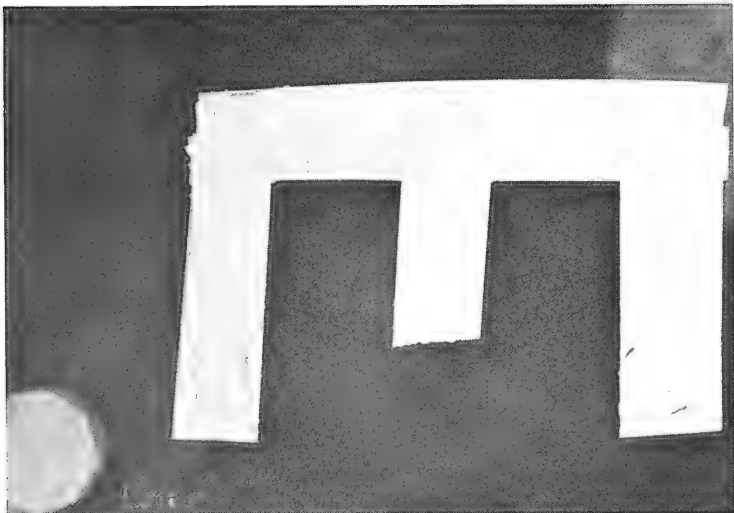
The condition of the syntactic foam blocks of the foam tower is illustrated in Figure 15. Although the coating at the identifying letter had failed, the underlying material was unattacked. No signs of water absorption or deformation of the foam blocks of the foam tower, low frequency antenna or gas generator support was noted. The main lifting eye at the top of the foam tower, as shown in Figure 16, was covered with a thin film of loose flaky red rust but no significant corrosion was noted underneath the rust layer.

Figure 15. Portion of foam tower.

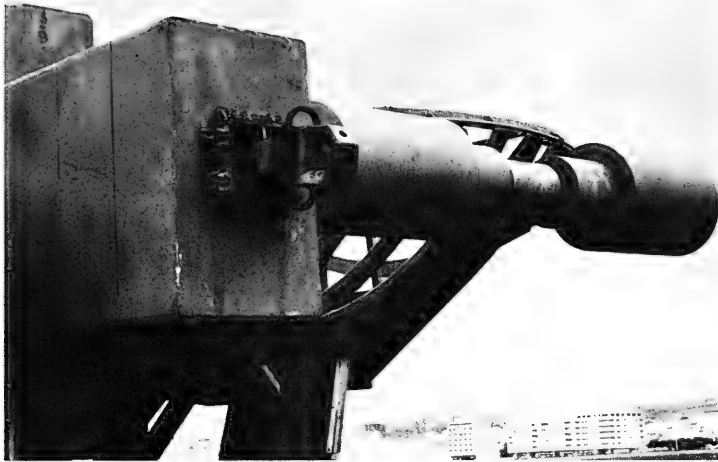
Figure 16. Main lifting eye at top of foam tower.
